# Installation Instructions

24xLink – 24/1x Signal Kit

## Introduction

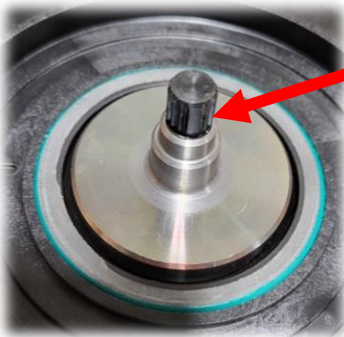
Figure 1 – Spline drive shaft

The early LT engine Optisparks were driven by Spline shaft. This spline shaft, on the optispark, has an index tab which correctly mates with the camshaft spline since it has a mating index notch. This notch indexed spline ensures that the TH 24x Signal unit installs and is oriented correctly with engine position.

Index tab/  
Notch

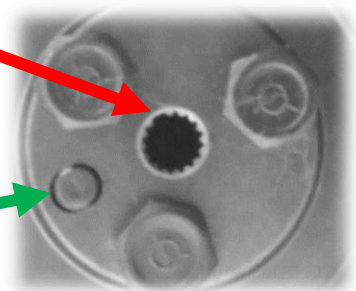
Figure 2 – Spline drive hole in camshaft timing gear

Cam Dowel  
**flush** with  
cam gear

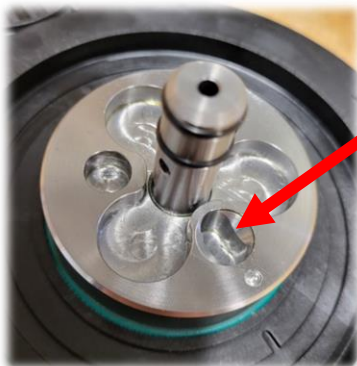
Figure 3 – Pin drive spindle. Has locating slot for cam dowel pin.

The later LT engine Optisparks were driven via an extended camshaft timing gear dowel pin. The camshaft dowel pin is longer than the camshaft dowel pin on early year engines and protruded into the Optispark pin drive spindle. This pin drive ensures the later Optisparks only installed in one way and were properly oriented to engine position.

Drive Pin

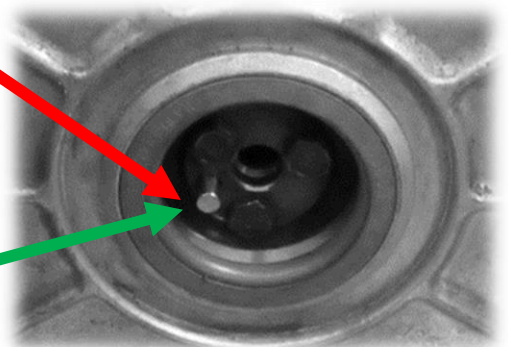
Figure 4 – Pin drive Optispark drive dowel pin.

Cam dowel  
**protrudes**  
through cam gear

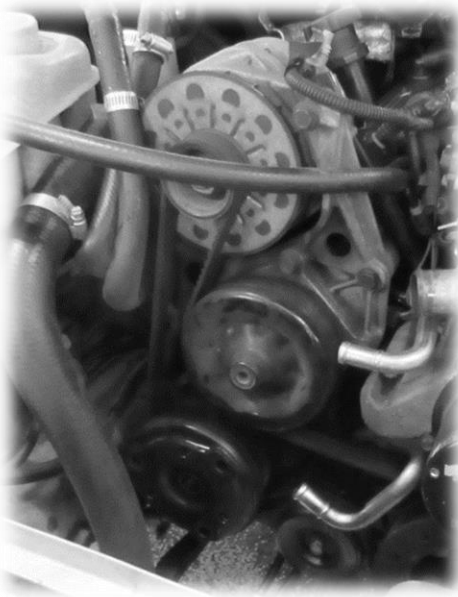
Figure 5 – Heater core hoses removed

1. Disconnect the negative battery terminal.
2. Locate the radiator petcock or optionally the lower radiator hose and drain the engine coolant from the system.
3. Disconnect the MAF, IAC, and IAT connectors. Remove the intake air duct work.
4. Once the coolant is drained, loosen and remove the upper radiator hoses from the radiator (Fig. 5).
5. Remove the heater core hoses from the water pump housing. Be prepared for these to drain additional fluid that was not completely drained during previous steps. (Fig. 5)

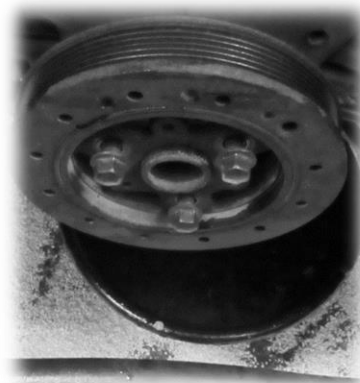
Figure 6 – Crank pulley bolts being removed

6. Remove the serpentine drive belt by rotating the spring loaded idler pulley. Use caution as this pulley is spring loaded. Once the belt is removed the idler pulley will settle beyond its usual position.
7. Remove the three bolts that hold the crank pulley to the crank hub. (Fig. 6). Remove the pulley from the crank hub.

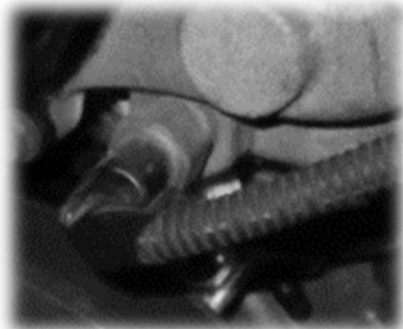
Figure 7 – ECT sensor connector

8. Disconnect the water pump ECT sensor connector. (Fig 7)

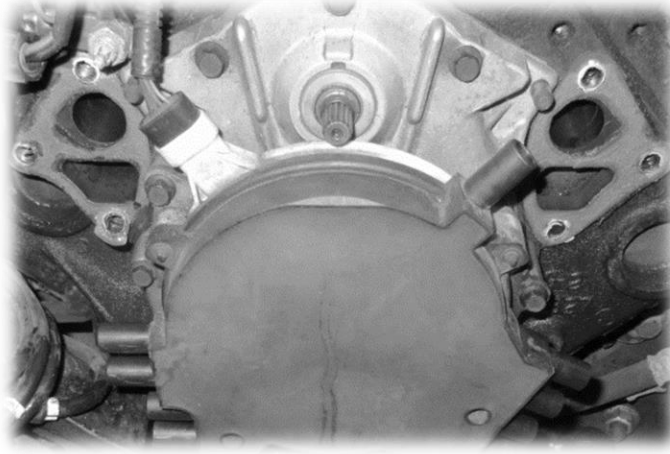
Figure 8 – Water pump removed

11. You should now be able to remove the water pump. It may need some nudging to knock it loose from the engine. Do not use hammer, or high force as you may crack the housing. Again be prepared for coolant to leak. (Fig 8)

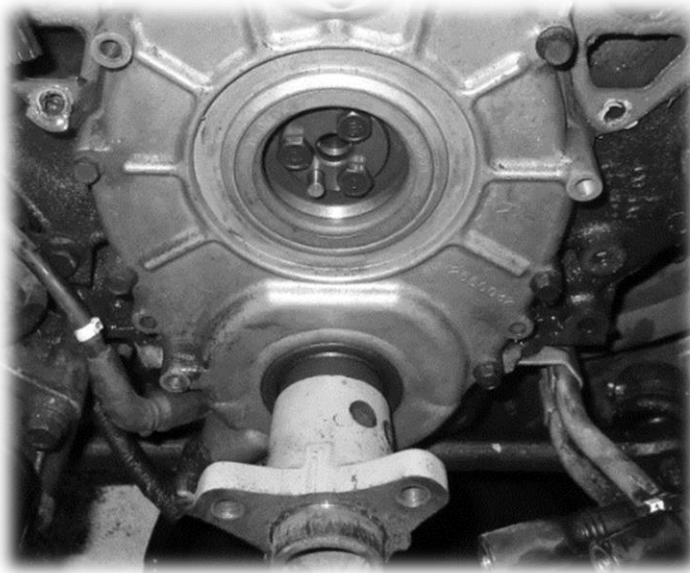
Figure 9 – Optispark Distributor removed. Late model type shown.

12. Complete access to the Optispark distributor is now complete. Disconnect the spark plug wires, coil wire, and distributor signal connector from the distributor. If equipped also disconnect the vacuum line from the distributor (late model Optisparks only).
13. Remove the three bolts that secure the Optispark distributor to the front timing cover of the engine. The Optispark can now be removed.

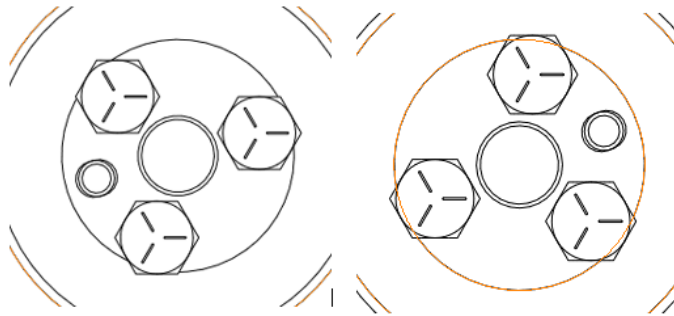
Figure 10 – Acceptable cam dowel positions when viewed straight on from front of engine. Viewable when using late model type pin drive.

14. Rotate the engine so that the cam dowel pin is in either position (8 o'clock or 2 o'clock) shown in Figure 10. If your engine is the early type spline drive rotate the engine so that the spline drive index notch is in either the 5 o'clock or 11 o'clock position (You will have to use a light to peer through the spline drive hole in the front timing cover).

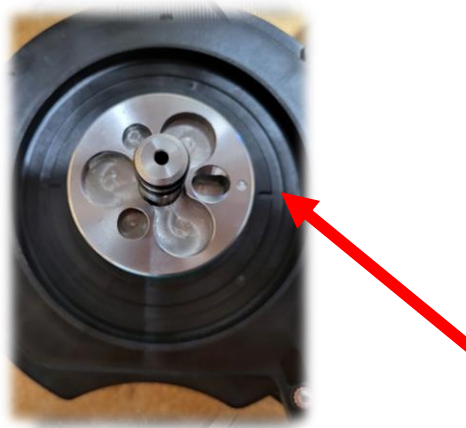
Figure 11 – Pin drive slot pointing at #1 indicator marking.

Pin Drive: Drive pin slot pointing at #1 indicator (Fig 11.)

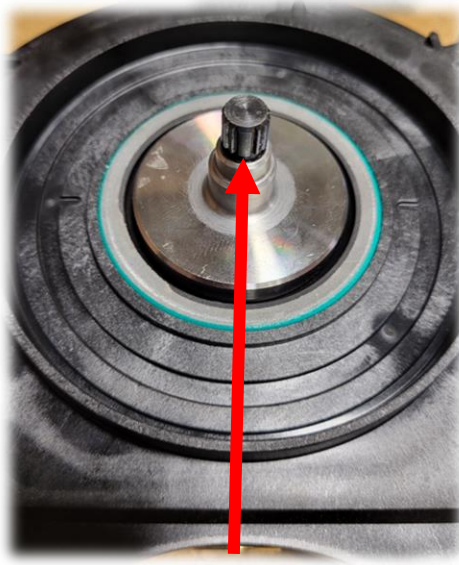
Figure 12 – Spline drive tab in 6 O'clock position.

Spline Drive: Sensing unit drive tab in 6 o'clock position as shown in Figure 12

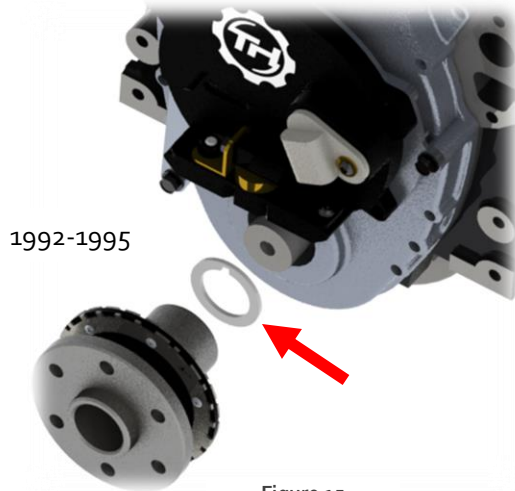
Figure 15

5. Install the TORQHEAD 24x crank hub, ensuring to align the crank hub keyway with the crankshaft key. Install the supplied crank hub spacer prior to installing the hub if your vehicle is a 1992-1995 vehicle (Fig 15). Do not use the supplied spacer if your vehicle is 1996+ (Fig 16). Note: This hub is a press fit onto the crank snout so it will need to be pulled on. **NEVER** use a hammer to drive it on.

Crank hub spacer installed.	If your vehicle is a 1996+ you do not require the supplied crank spacer. Installing the spacer will only result in the hub being installed farther forward.
	Crank sensor mount adjusting screws are tight.	Loosen the crank sensor mount screws slightly so that the mount can slide back and forth while inserting the crank sensor alignment tool. If these screws are tight they will not allow the mount to center.

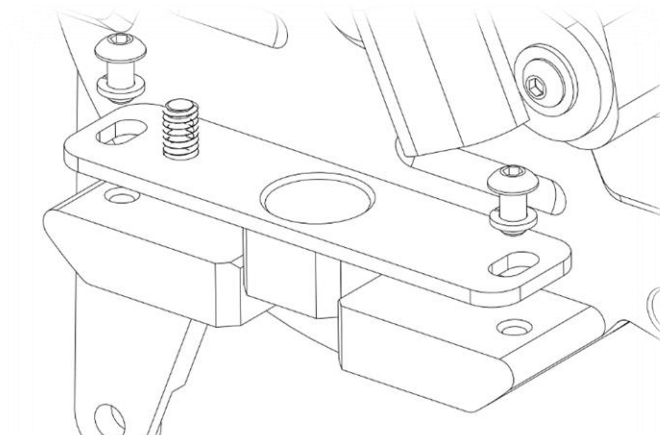
Figure 17

6. Install and torque the crank hub retaining bolt to manufacturer spec.
7. If not already performed, install the crank sensor mount onto the sensing unit. Two small M5x0.8mm bolts and serrated washers retain the crank sensor mount (Fig 17). Do not fully tighten the two screws, leave them loose enough that the crank sensor mount can slide back and forth.

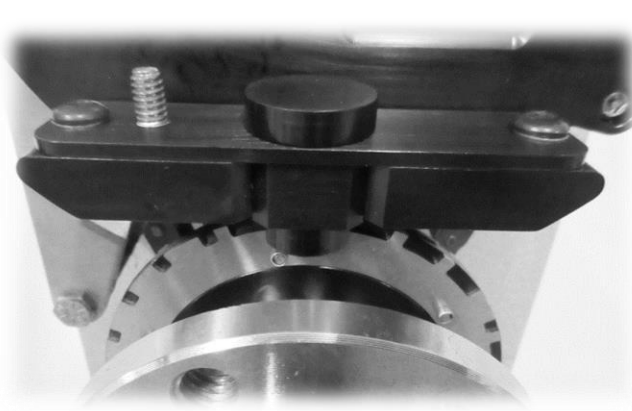
Figure 18

8. Insert the crank sensor alignment tool into the crank sensor mount. Once fully inserted this tool will setup the position of the crank sensor mount such that it, and the crank sensor, are centered over the 24x reluctor wheel. When inserting the tool ensure the slot/notch in the tool runs side to side and engages the 24x crank reluctor on the hub. Also ensure the tool is fully seated. See figures 18 and 19.

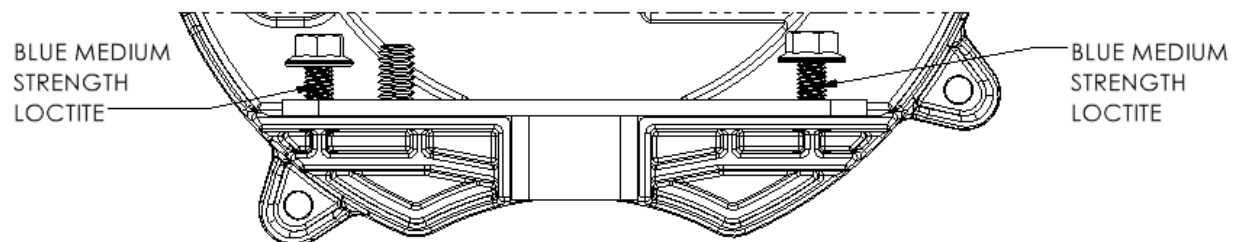
9. With the centering tool in place from step 8, now back off the two crank mount screws and apply a small amount of blue Loctite to the bolt threads. See figure below.

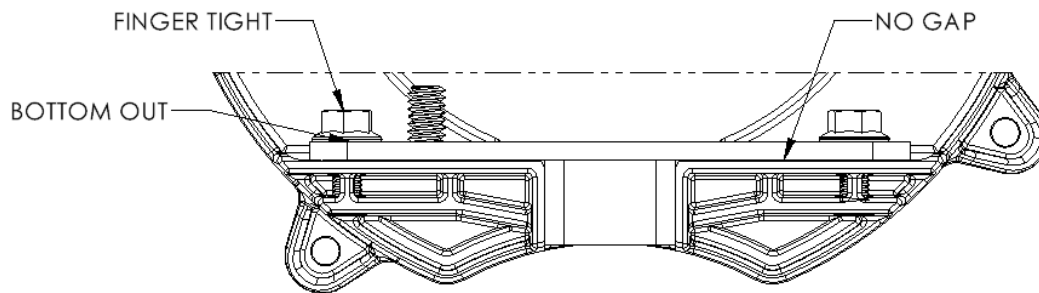
10. Thread the two screws down by hand and bottom them each out to a fairly strong FINGER TIGHT. There should also be no gap between sensing unit shelf and crank mount. The goal is to take out all the gaps, with finger tightening, prior to the final torquing procedure. See figure below.

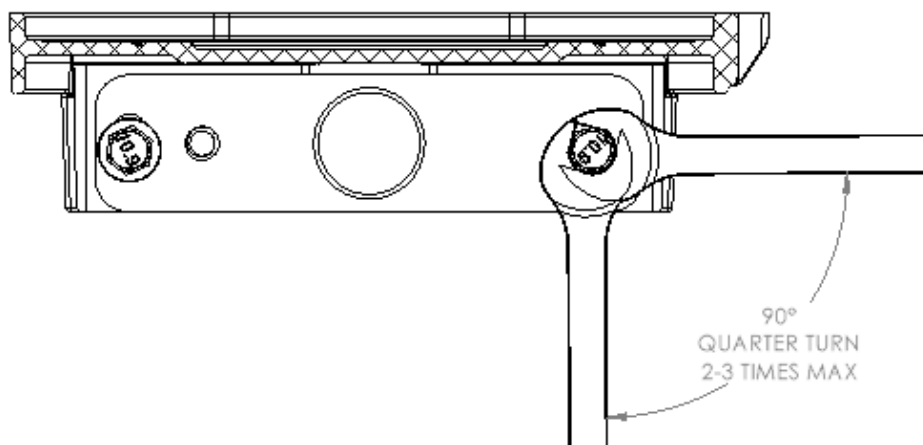
11. Now using 8mm (or 5/16") wrench apply two to three quarter (1/4) turns of the wrench to each screw. See figure below. This is equal to turning the screw one half turn to three quarters turn in total. It is recommended to do a quarter turn on one screw at a time to tighten them evenly and progressively. Quarter turn on one screw, quarter turn on the other screw, final quarter turn on first screw and then final quarter turn on 2<sup>nd</sup> screw. After two quarter turns it should have felt quite tight, if it felt like it still wanted to become tighter you can do one final third quarter turn. Three quarter turns is only needed (absolute maximum) due to perhaps the finger tightening/gap removal from step 10 might have been smidge loose before using wrench. You should never need to exceed three quarter turns after doing step 10 above or you risk damage.

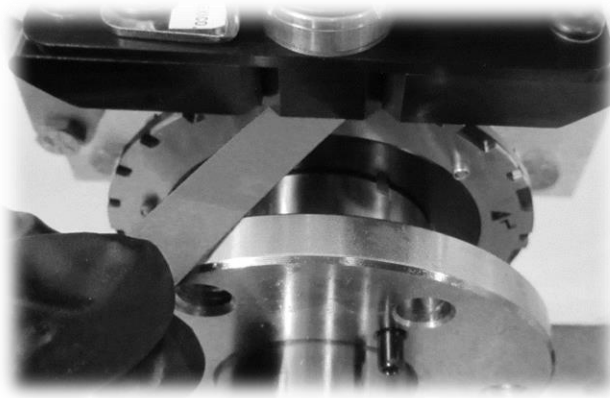
Figure 21

12. The crank sensor mount is now centered over the reluctor, and is securely tightened down.
13. Remove the crank mount alignment tool.
14. Install the crank sensor **without** any of the stainless adjustment shims. Install the 1/4-20 flange head nut that retains the crank sensor.
15. Dial in crank sensor air gap: Using the supplied yellow feeler gauge, test the crank sensor to reluctor air gap. Do this by trying to slide the yellow feeler gauge between the crank sensor and 24x reluctor as shown in Figure 21. Without any crank sensor adjustment shims installed (as per step 14) the yellow feeler gauge should not slide thru. If it does slide thru, with no shims, then loosen the three retaining bolts and ever so slightly pull down on the sensing unit. Then re-tighten the three retaining bolts. It might have been the case where the sensing unit was bolted down, ever so slightly, too high.

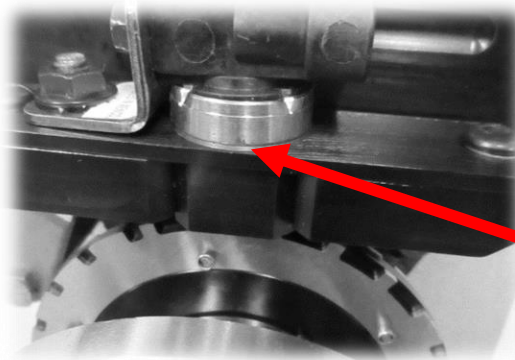
Figure 22

16. Remove the crank sensor and add one of the supplied round stainless shims under the crank sensor. Reinstall the crank sensor, ensure it seats fully and ensure to tighten the retaining nut down. See Figure 22.

Crank sensor  
adjustment  
Shim(s)

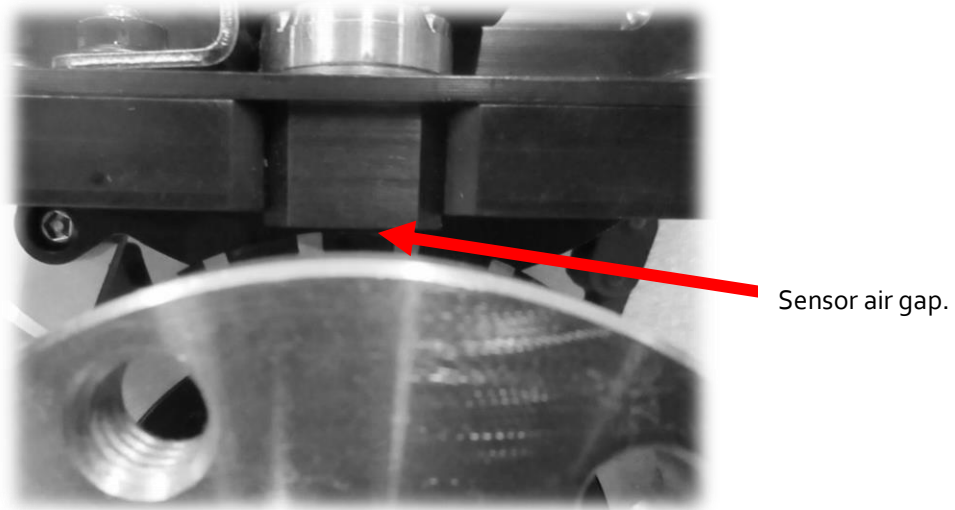
Figure 23

17. Test the air gap again with the yellow feeler gauge. If it passes through, even if slightly tight, that is OK the crank sensor air gap is now set (Figure 23). If it still does not pass through repeat step 16 & 17, adding one shim at a time, until the yellow feeler gauge passes through. What you want to shoot for is light drag on feeler gauge or one shim extra. Don't make it too tight by trying to force the feeler gauge thru.
